## Thermal Imaging Tests on Generator Set Systems

Information Sheet # 19

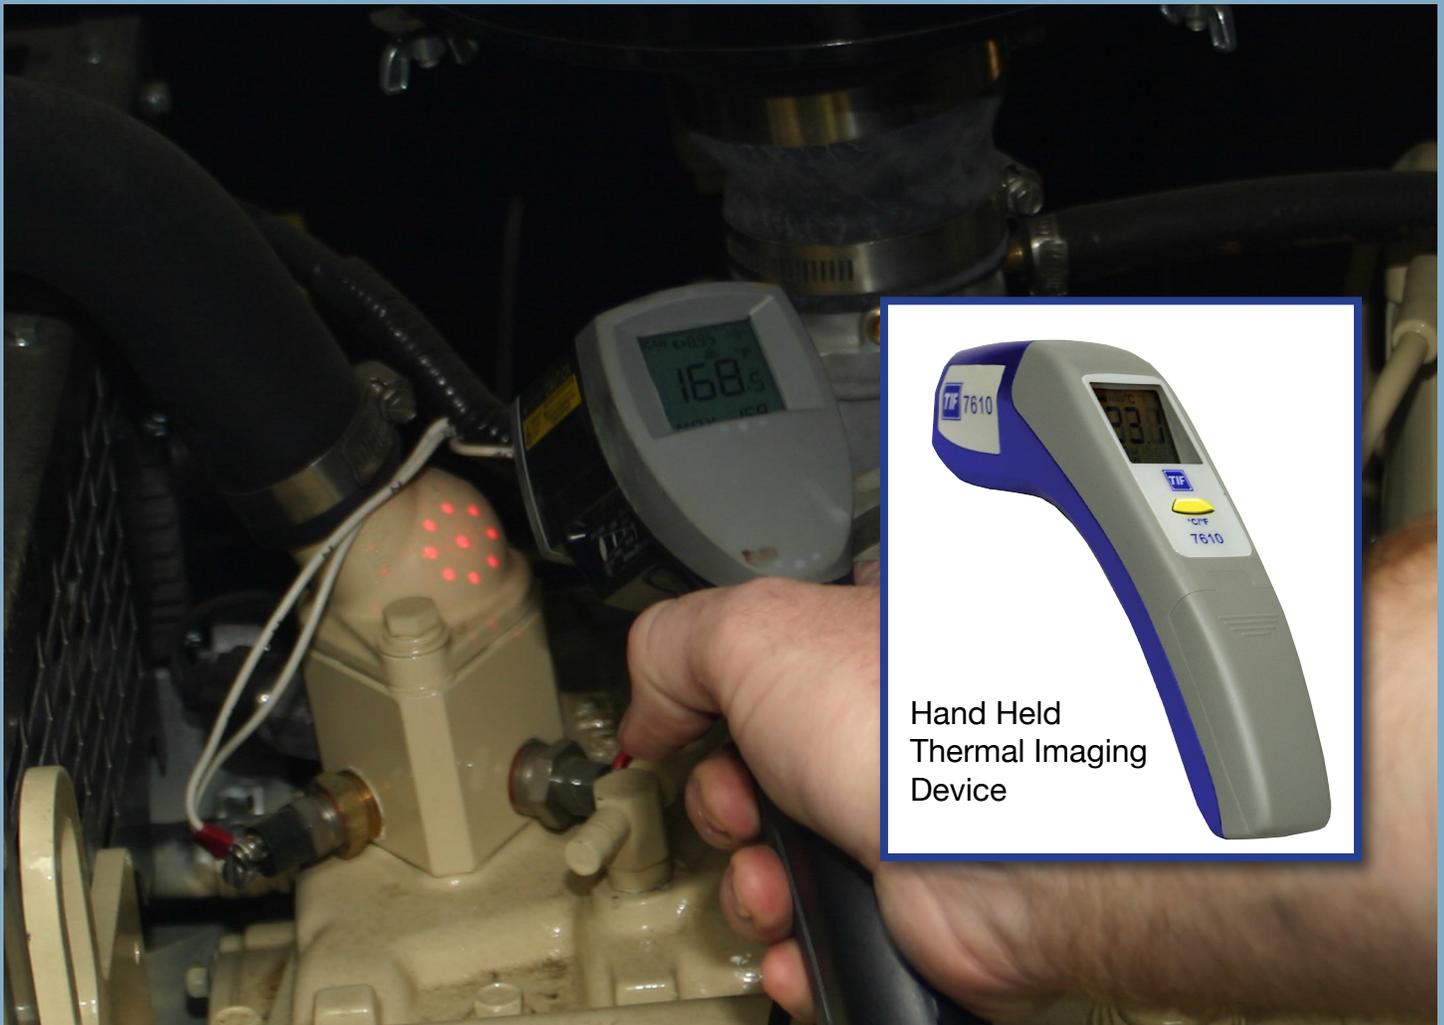
Hand Held  
Thermal Imaging  
Device

The technician points the imager at the equipment in question, scans the immediate area for unexpected hot spots, then squeezes the trigger to capture a specific image. Once the inspection has been completed, the saved images can be uploaded to a computer for closer analysis, reporting or future trending. While imagers are simple to operate, they are most effectively employed when in the hands of a qualified technician, who understands electrical measurement and the equipment being inspected.
